**UNITED STATES OF AMERICA
BEFORE THE
FEDERAL ENERGY REGULATORY COMMISSION**

**Complaint of Michael Mabee and Petition)
to Order Mandatory Reliability Standards) Docket No. EL21-99-000
for Equipment and Monitoring Systems)
Marketed from the People’s Republic of China)**

**MOTION TO INTERVENE AND COMMENT OF THE
SECURE THE GRID COALITION**

Submitted to FERC on September 15, 2021

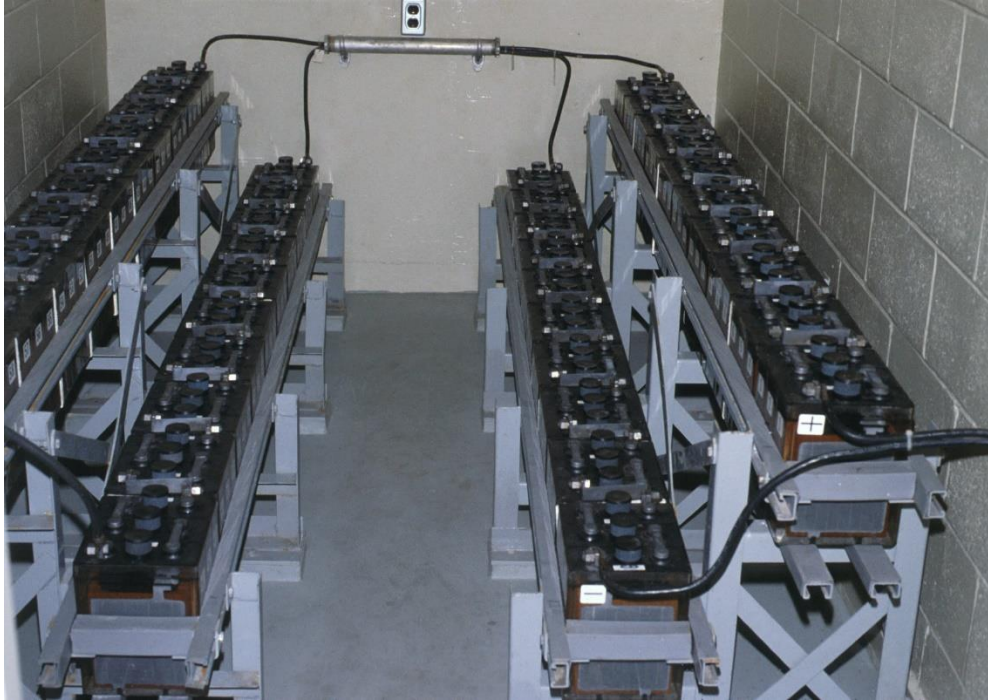
Fig. 3 (Source: Tennessee Valley Authority)

Should a nuclear plant become deprived of both the electricity from the offsite power grid and from the backup power supply, it experiences a station blackout where the only remaining source of electricity is direct current from onsite batteries. The batteries are normally kept fully charged from the alternating current systems through inverters and chargers. The station batteries are designed to supply sufficient electricity to a minimal subset of emergency equipment needed to cool the reactor core for 4 to 8 hours when it is assumed that either the connection to the offsite power grid will be restored or at least one of the backup power supplies will be repaired and returned to service.

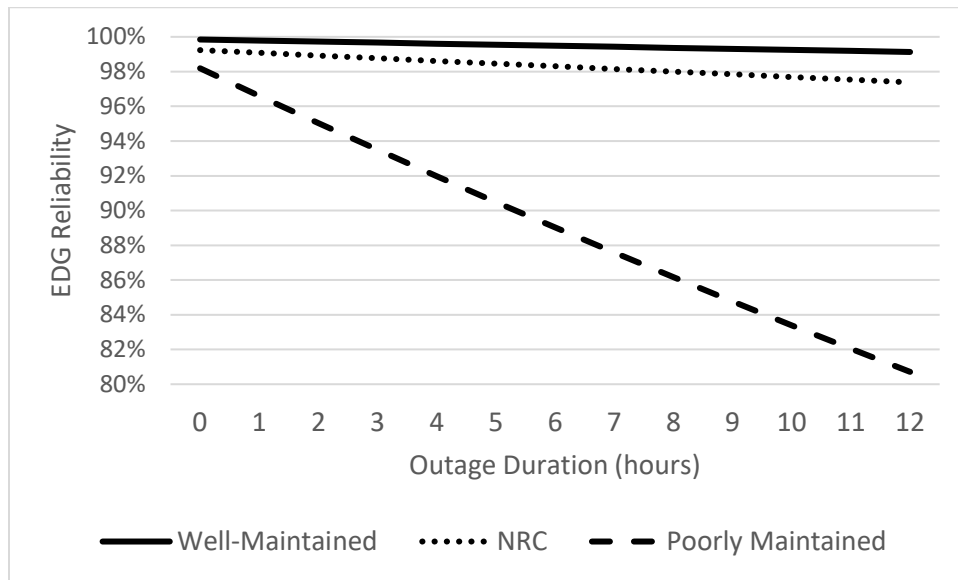
Figure 8. The reliability of a single EDG for outages less than half a day (12 hours)

In Figure 8, the same reliability results for outages up to 12 hours are shown to clearly illustrate the impact of different probabilities for FTS.

Not surprisingly, a poorly maintained EDG is unlikely to provide power for durations longer than a few days, and it has reliabilities of only 80% at 12 hours. These figures reinforce the importance of following the current guidance on EDG maintenance. But even well-maintained EDGs have a reliability of 92%-96% for providing backup power for four days (96 hours), 90%-95% at one week, and 75%-87% at two weeks (required for critical loads at some military facilities). Thus, a single EDG's reliability limits their ability to provide a robust source of emergency power for critical loads over multiday outages.
